SITE LOCATION AND MAPS PHOTO

Client	GAS MALAYSIA DISTRIBUTION SDN BHD
Project Title	PIPELINE INTEGRITY INSPECTION AND ASSESSMENT WORKS FOR GAS DISTRIBUTION MALAYSIA SDN BHD
Location 1	Jalan Kampung Dew (GPS No.: 4°49'25.2"N 100°42'16.5"E)(4.8236667,100.7045833)

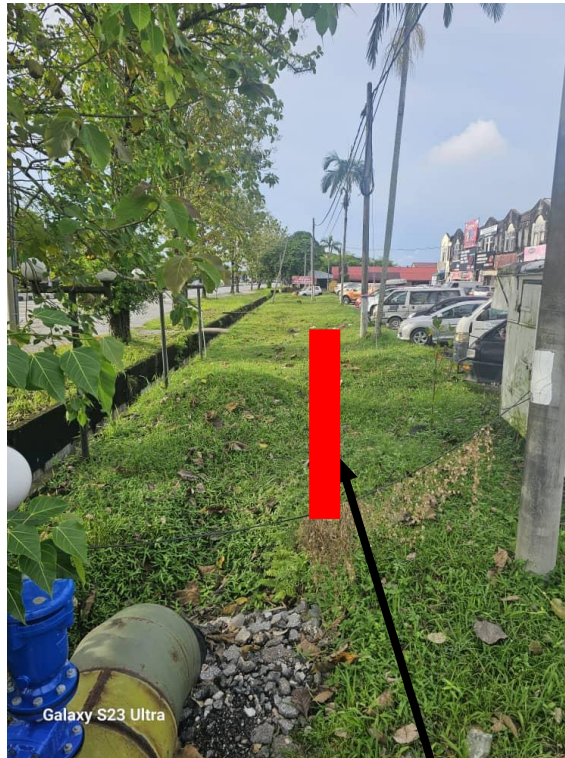
**Excavation Area
2.5m(L) X 2.5m(W) X 2m(D)**

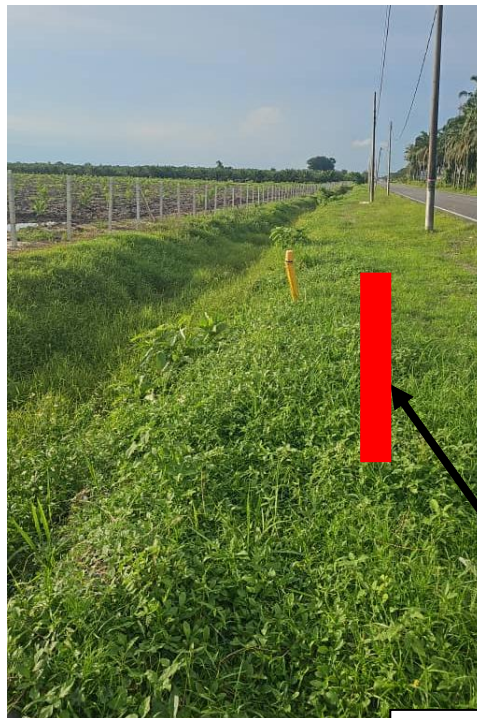
**Excavation Area
2.5m(L) X 2.5m(W) X 2m(D)**

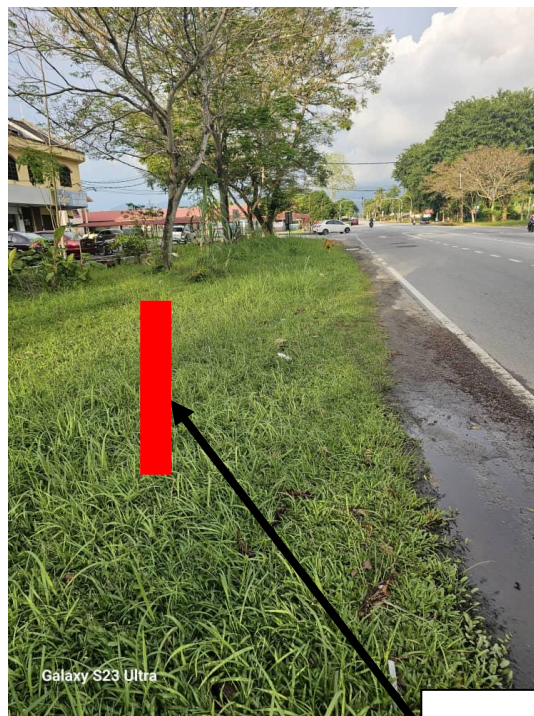
**Excavation Area
2.5m(L) X 2.5m(W) X 2m(D)**

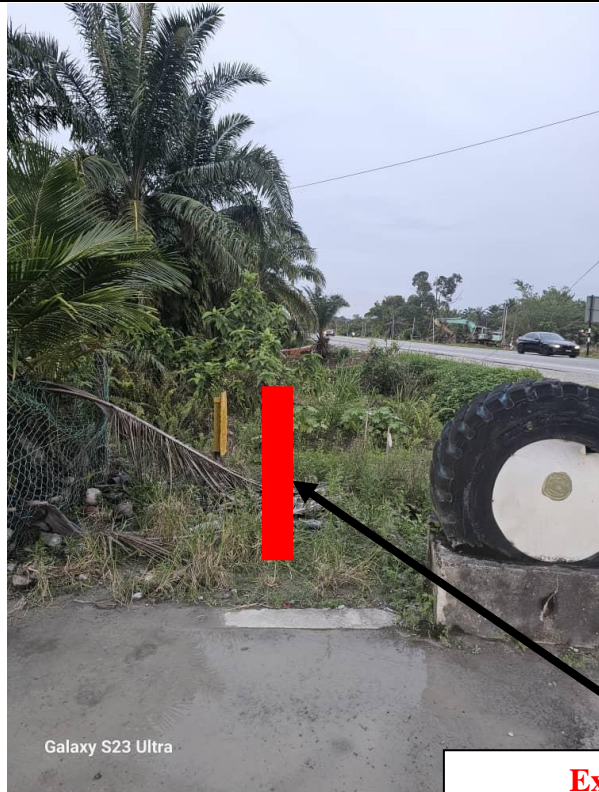
**Excavation Area
2.5m(L) X 2.5m(W) X 2m(D)**

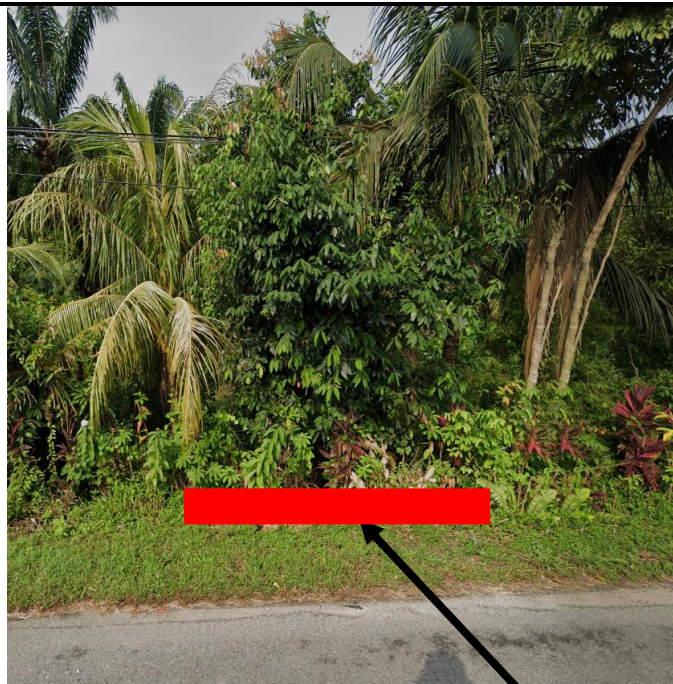
**Excavation Area
2.5m(L) X 2.5m(W) X 2m(D)**
