### SITE LOCATION AND MAPS PHOTO

<b>Client</b>	GAS MALAYSIA DISTRIBUTION SDN BHD
<b>Project Title</b>	PIPELINE INTEGRITY INSPECTION AND ASSESSMENT WORKS FOR GAS DISTRIBUTION MALAYSIA SDN BHD
<b>Location 1</b>	Jalan Kampung Dew (GPS No.: 4°49'25.2"N 100°42'16.5"E)(4.8236667,100.7045833)

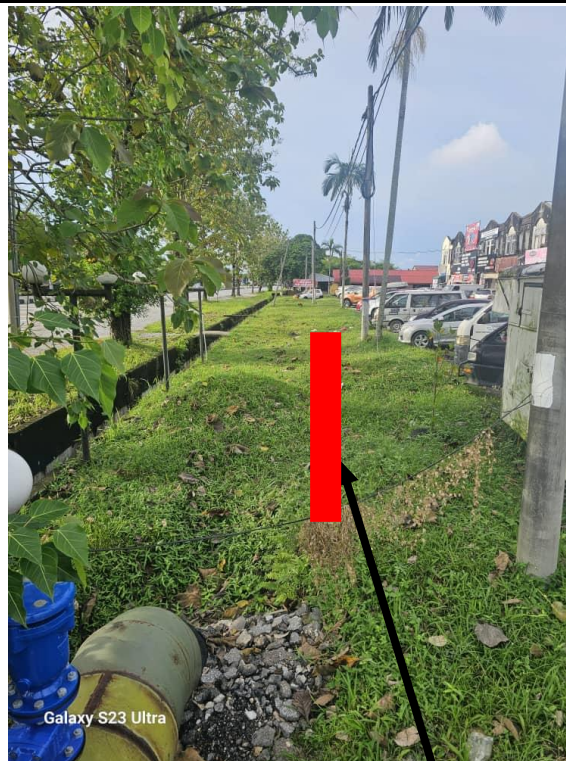
**Excavation Area  
2.5m(L) X 2.5m(W) X 2m(D)**

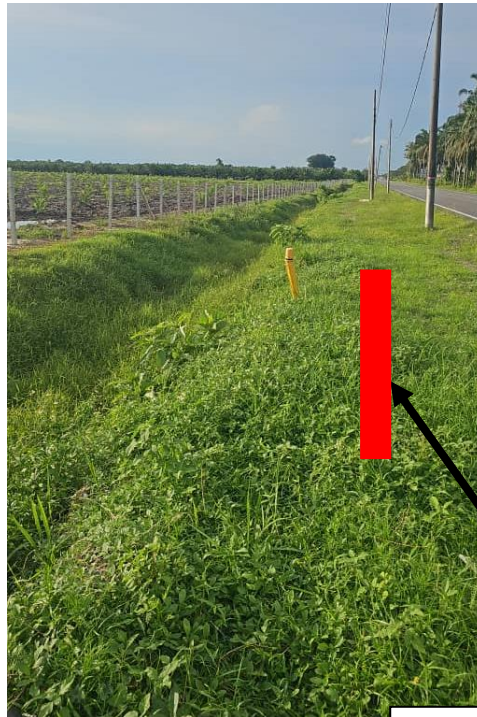
**Excavation Area  
2.5m(L) X 2.5m(W) X 2m(D)**

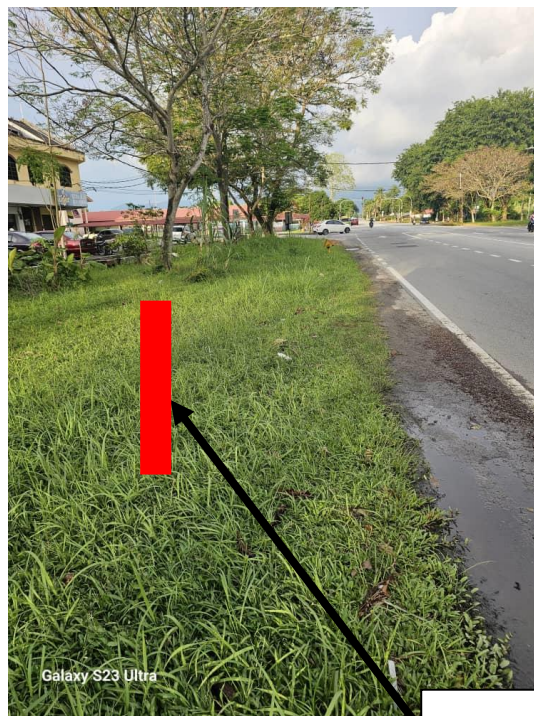
**Excavation Area  
2.5m(L) X 2.5m(W) X 2m(D)**

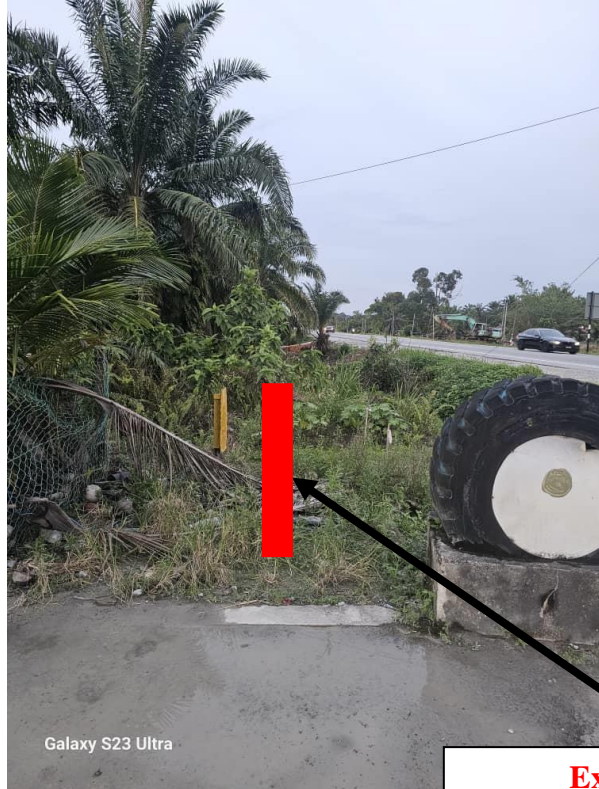
**Excavation Area  
2.5m(L) X 2.5m(W) X 2m(D)**

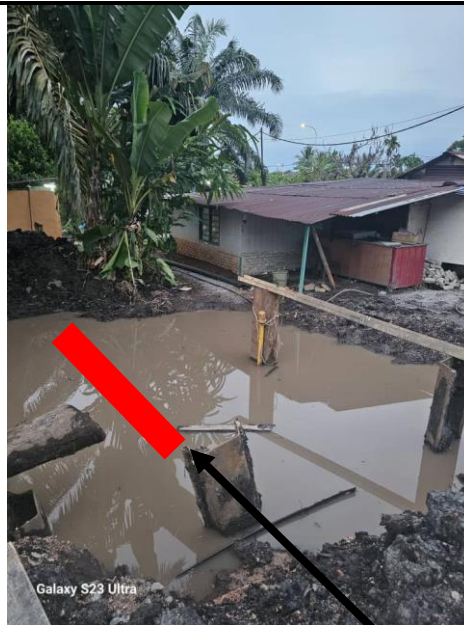
**Excavation Area  
2.5m(L) X 2.5m(W) X 2m(D)**
