**SDU SHOPLLOT JALAN
SATRIA**

PROCESS OF HDD AND MICRO TRENCHING (McT)

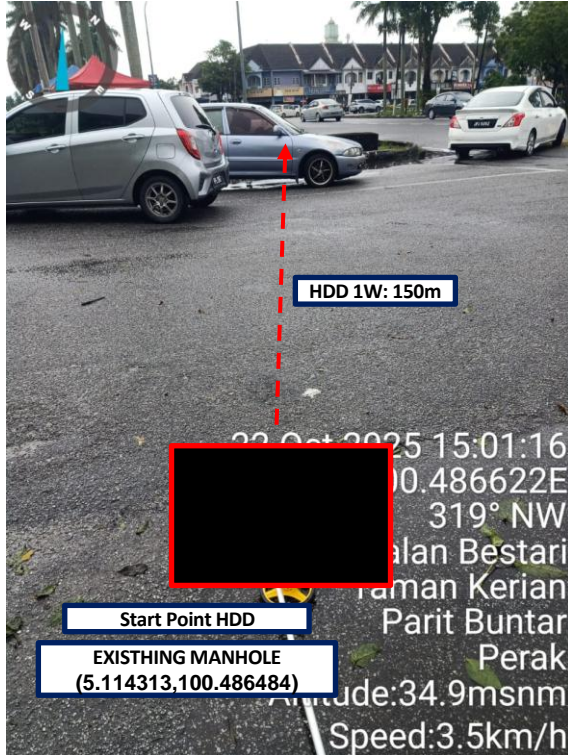
**REDMARK : EXISTING MANHOLE DARI SITE
SHOPLOT JALAN BESTARI.
BERHADAPAN KEDAI PASARAYA KU**

**1.1) SITE PHOTOS (GAMBAR LOKASI)
HORIZONTAL DIRECTIONAL DRILLING (HDD), (1 WAY : 150M)**

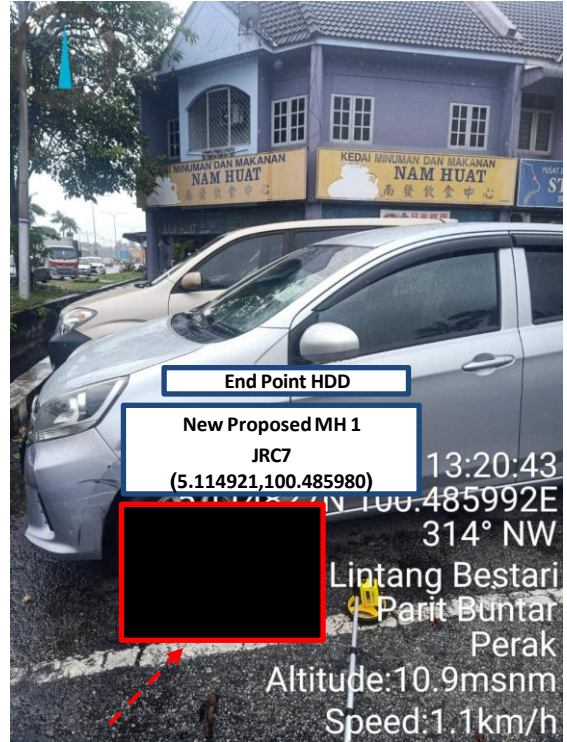
**REDMARK : PETAK PARKIR DISEBELAH KEDAI
MAKAN NAM HUAT**

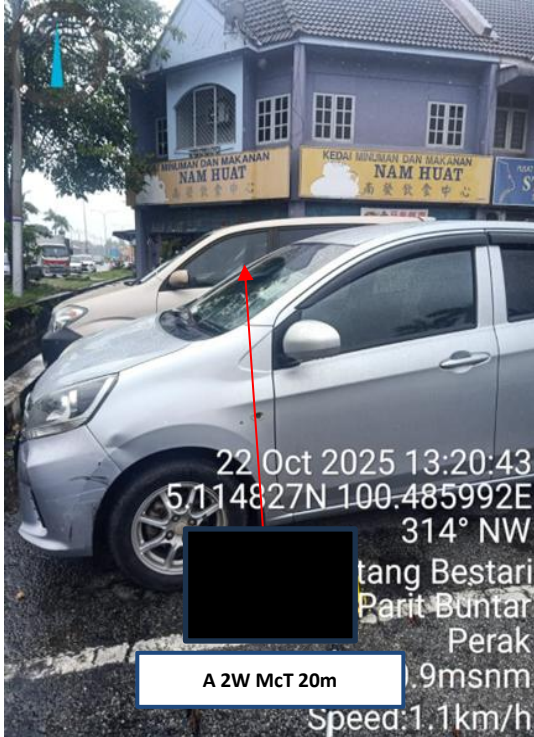
REDMARK: MCT DARI PROPOSED NEW MANHOLE KE BULDING KEDAI MAKANAN NAM HUAT

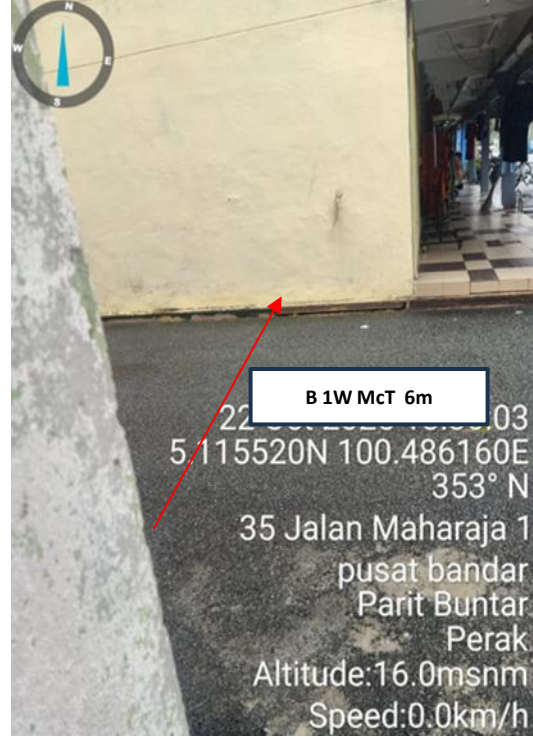
REDMARK: MCT DARI BANGUNAN KEDAI PERABUT VBA KE KEDAI PEMBORONG PAKAIAN HJ. MOHD SALIM

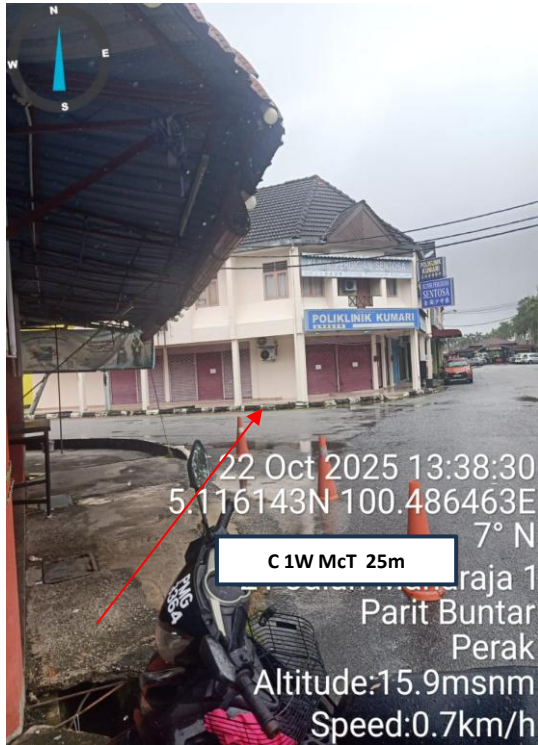
REDMARK: MCT DARI BANGUNAN WALINONG SARI KE BANGUNAN POLIKLINIK KUMARI

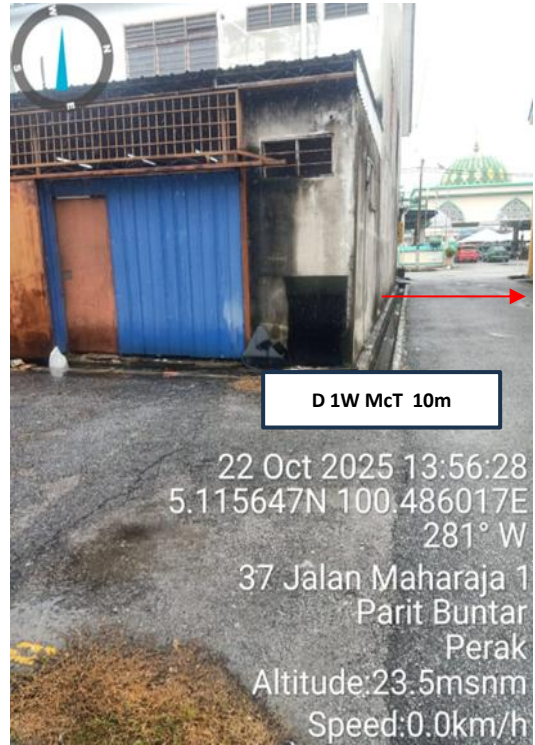
REDMARK: MCT DARI BANGUNAN RESTORAN DELICIOUS MOTEN-MOTEN KE BANGUNAN MARWANS HALAL MART
